U.S. Department
of Transportation
**Federal Highway
Administration**

Guardrail Testing Program

Final Report

Publication No. FHWA-RD/FLP-90-087
May 1990

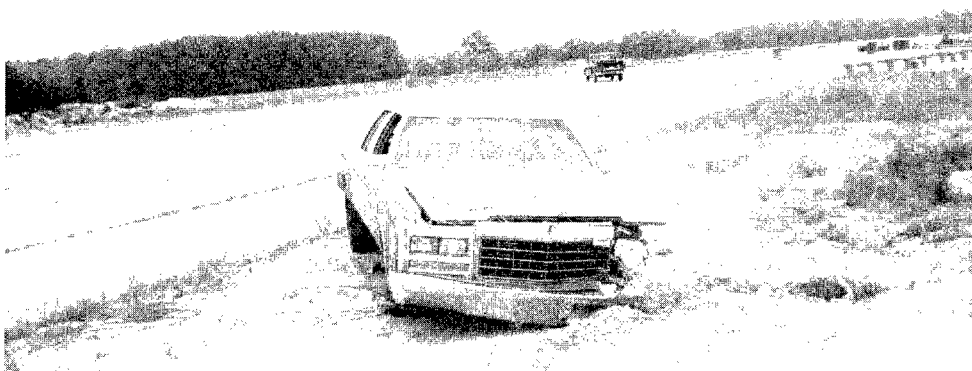
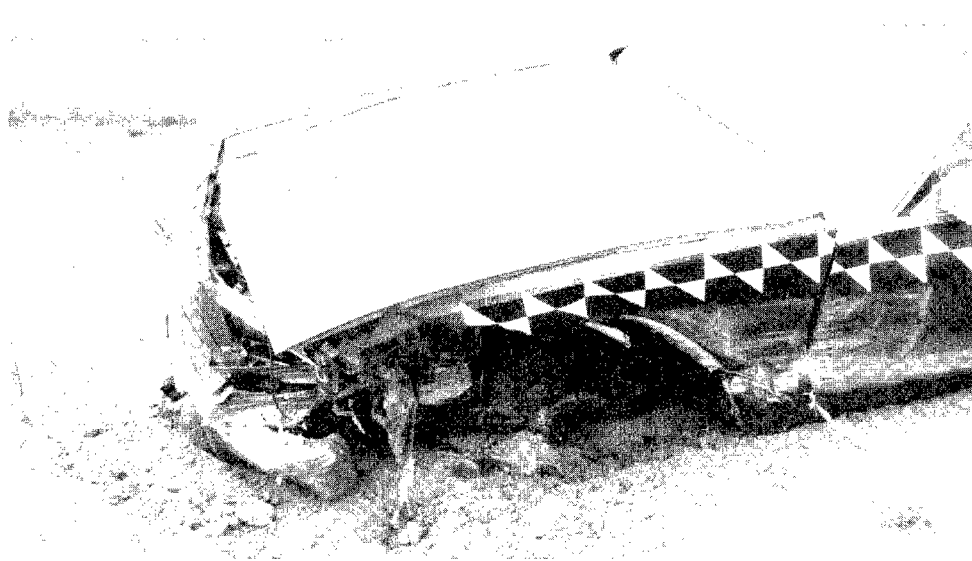
Figure 96. Posttest photographs of test vehicle,
test 1818-14-88.

d. Vehicle Damage

Vehicle damage occurred mainly to the left side and front of the car. The left front fender, grill, bumper, drivers door, and vehicle steering suspension were damaged significantly. The left front wheel was turn off in the impact with post number 5. No vehicle glass was broken during the impact. Posttest photographs of the vehicle are shown in figure 96.

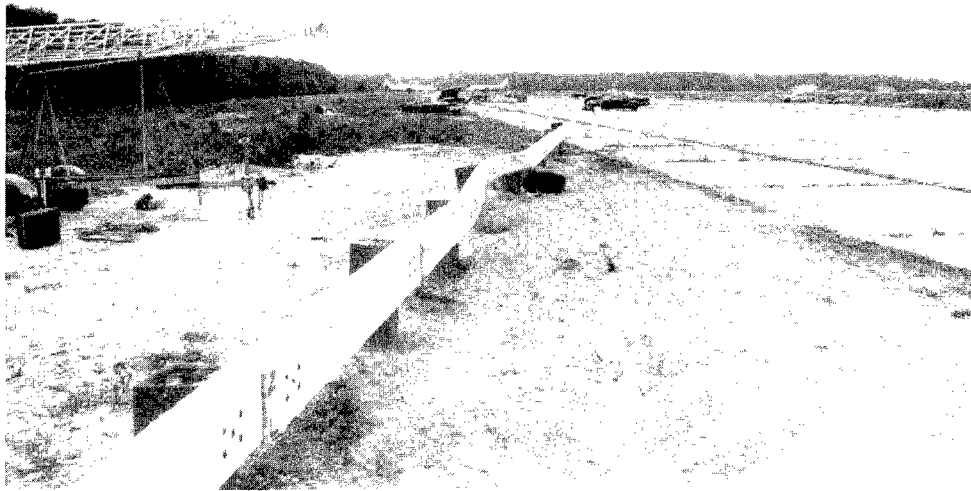
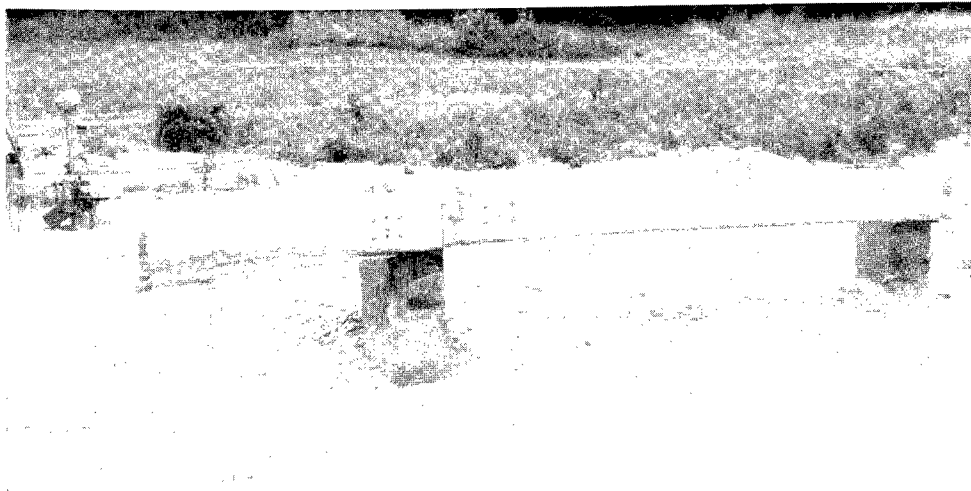
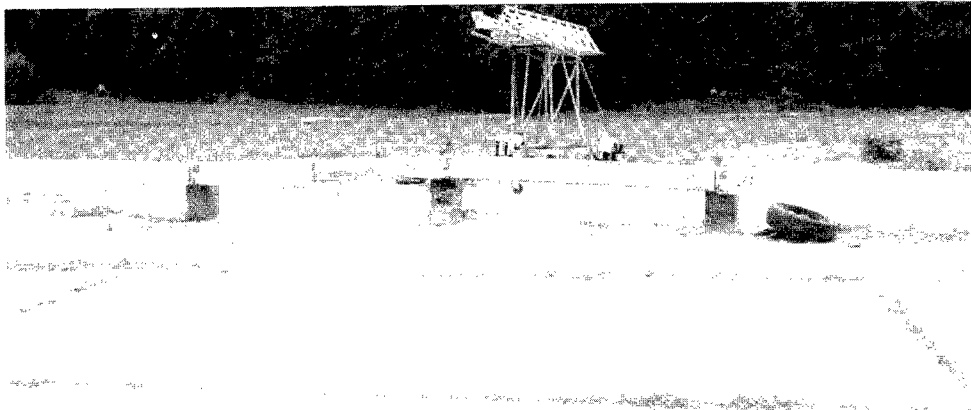
Figure 97. Posttest photographs of guardrail system, test 1818-14-88.

Upon impact, the front of the vehicle was deformed. The left front tire became wedged under the rail and was torn off in the impact with post 5 when post 5 rotated after the impact, the rail rose above the standard height. It is felt that the car getting under the rail caused the rail to rise and not the converse. The vehicle then yawed around and exited the rail. The vehicle remained in contact with the rail for approximately 15 ft (4.6 m). The vehicle was redirected at a speed of 24.8 mi/h (11.1 m/s) and at an angle of 8 degrees. The vehicle came to rest 155 ft (47 m) downstream of the impact point, 35 ft (11 m) behind the line of the guardrail.

e. Guardrail Damage

This guardrail performed adequately. The vehicle getting under the rail caused the rail to rise. The left front wheel of the vehicle was torn from the car in the impact with post 5. Posts 4 and 6 were pushed back 1 in (0.03 m) and post 5 was pushed back 5 in (0.13 m). Posttest photographs of the guardrail are shown in figure 97.
